Chatham Islands

Surface Water Summary 2020-21

Environment Canterbury Science Summary:
Adrian Meredith, Sebastian Stevens and Shontelle Milne

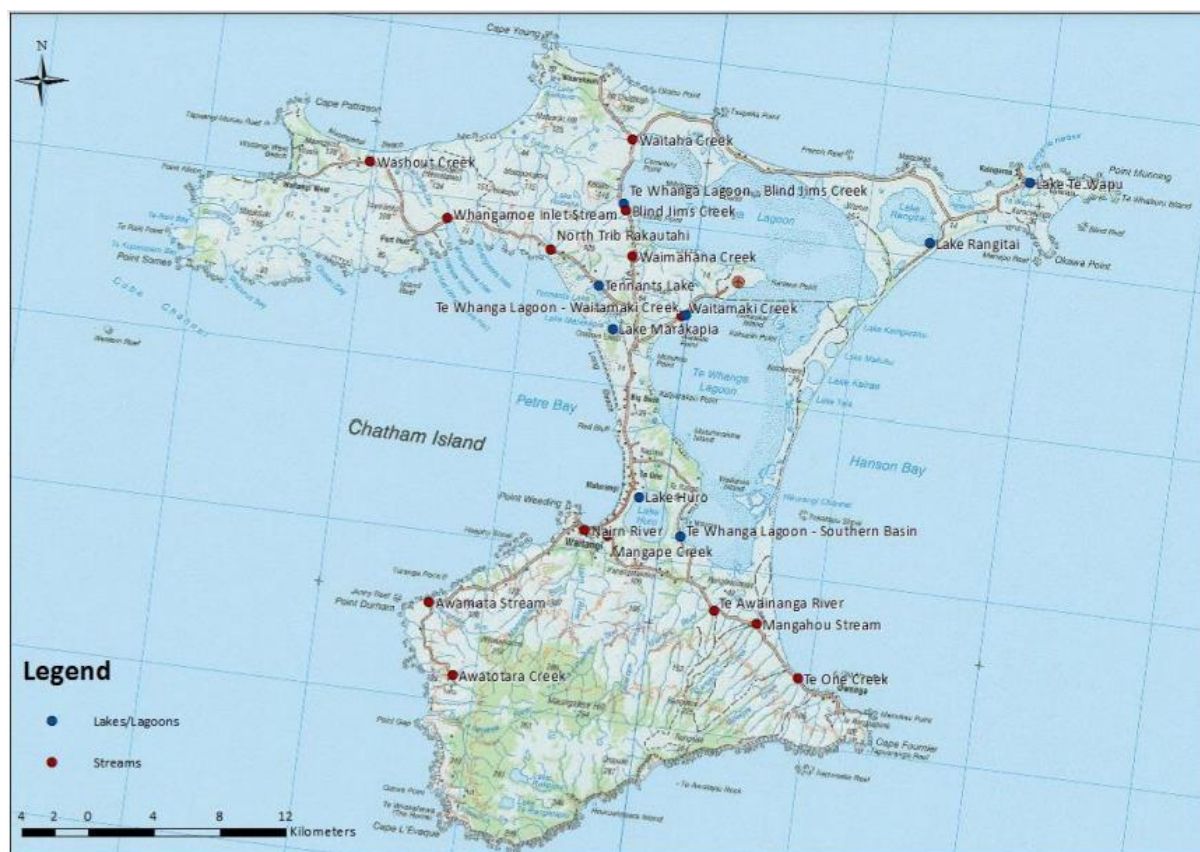
Figure 2-1: Map of Chatham Island showing the river, stream, lake and lagoon water quality monitoring sites

Long term water quality monitoring data is collected quarterly from 22 stream, lake, and lagoon sites across the main island of the Chatham Islands (Figure A1, Table 2-1). The streams and rivers are sampled at single easily accessible locations near the lower end of their length (Figure 2-1). The lakes are also sampled from easily accessible lake edge sites by wading rather than by boat. Te Whanga lagoon is also sampled from the lagoon edge by wading at three distinct locations representing the three distinct basins. Sampling began in 2005 for most of the sites, excluding Nairn River and Te Whanga Lagoon at the Southern Basin, which were first sampled in 2006.

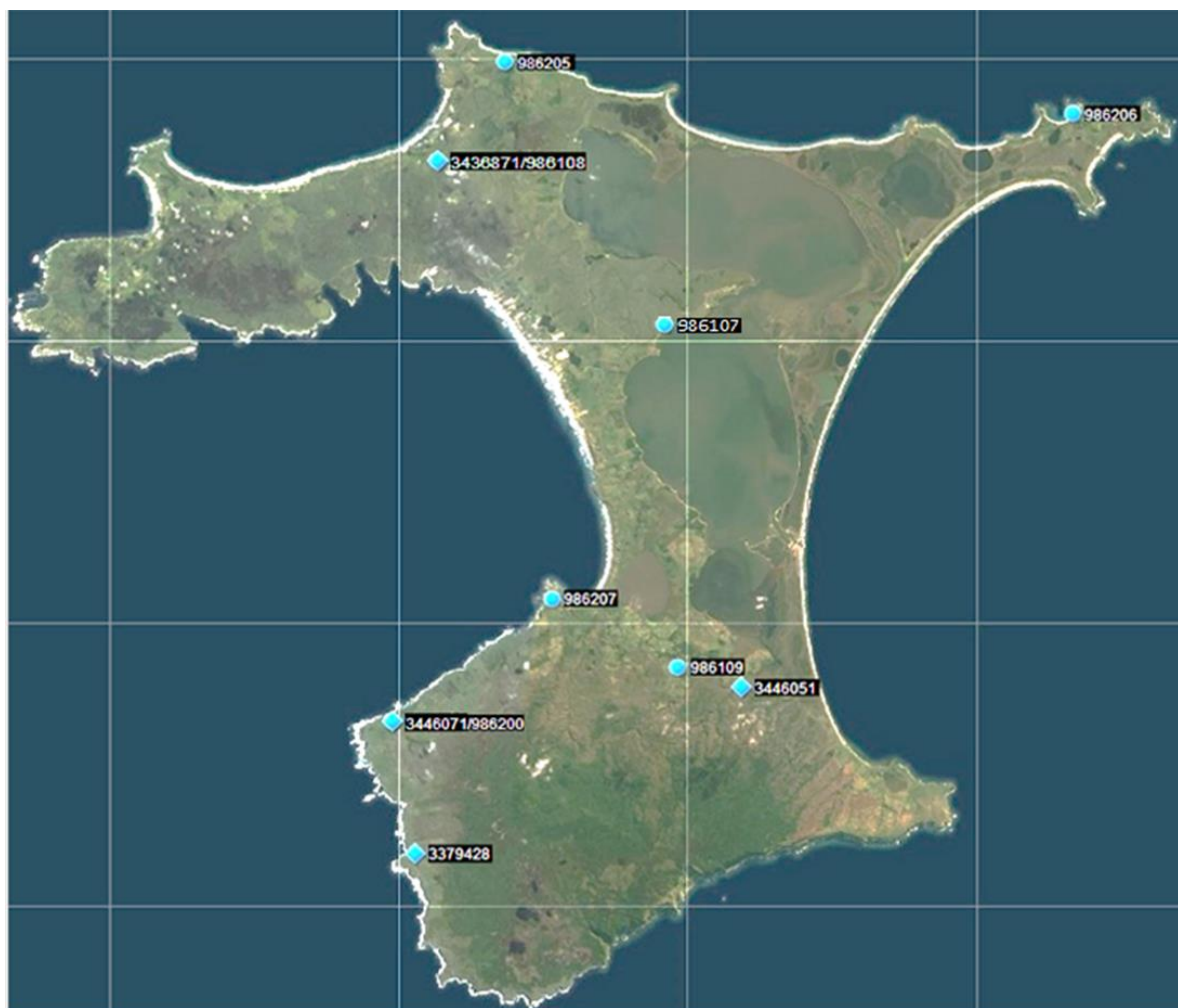
Figure 4-1: Environment Canterbury rainfall and flow stations across Chatham Island. Site names are found in Table 2-2 (Site 986107 is the NIWA Airfield site)

There are six Environment Canterbury operated rainfall stations, three in the northern part of the island and three in the south of the island (Figure 4-1). Chatham Island also has four long term flow recorders on the four largest surface water drainages (rivers) on the island. Three flow recorder sites sit alongside rainfall sensors; one of these flow recorders is on the northern half of the island and three are on the southern part of the island (Figure 4-1). The recorders measure the water height and then convert it to flow using information from the river profile, which is collected every time the river is gauged (generally 4 to 6 times per year). It is important to maintain these recorders so that we can establish long term trends and determine whether there are any natural or anthropogenic influences on river flow requiring clarification or management.
