Chatham Islands

Surface Water Summary 2021-22

Environment Canterbury Science Summary:
Adrian Meredith, Sebastian Stevens and Sian Barbour

July 2023

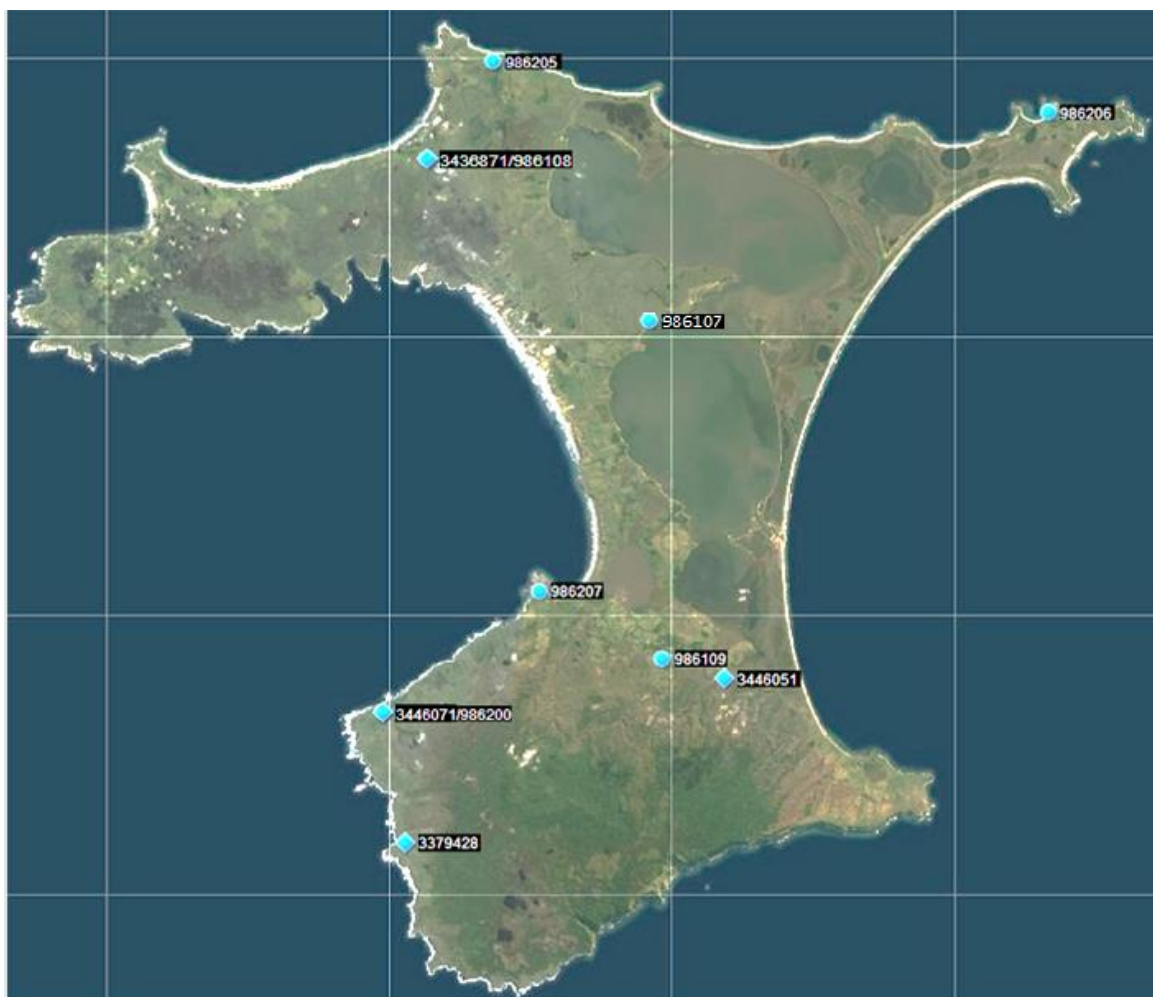
Figure 4-1: Environment Canterbury rainfall and flow stations across Chatham Island. Site names are found in Table 2-2
