BOARD PACK

Council Meeting

Thursday, 13 February 2025 9:00 am (+1345)

Condition Assessment and Repair Recommendations for Conservation of the Chatham Islands Surfboat

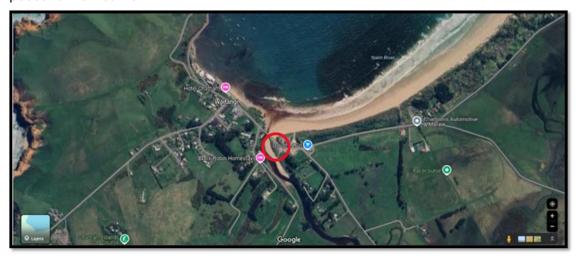
Figure 1 Location of surfboat in Waitangi

The surf boat is on council reserve between the Fulton Hogan yard and the Waitangi Wharf Owenga Road.

The boat was moved here in the 2000s. The surf boat rests directly on the ground and is exposed to the weather.

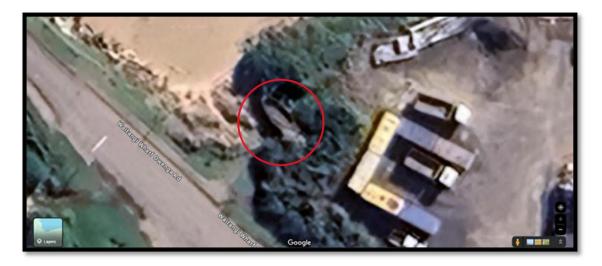
Figure 2 Location of surfboat

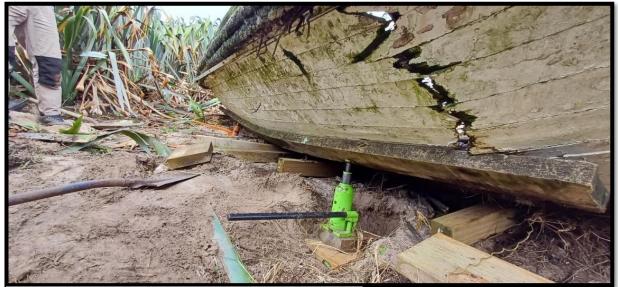
Figure 6 Surfboat getting lifted for inspection during survey.

Although the boat has been exposed to the elements outside, it is still in sound enough condition to be conserved. Because the boat was lying directly on the ground during the condition survey, it was decided that the hull would be lifted with bottle jacks to inspect the buried planking and keel.

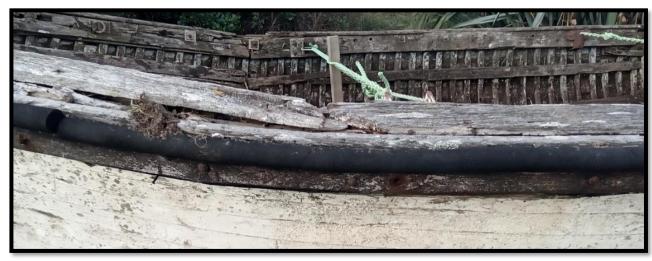
Figure 7 Cracked gunnel

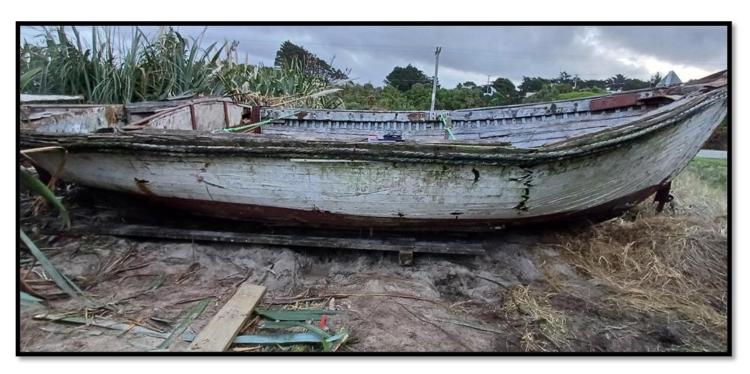
Figure 8 Starboard side planking. Note cracking

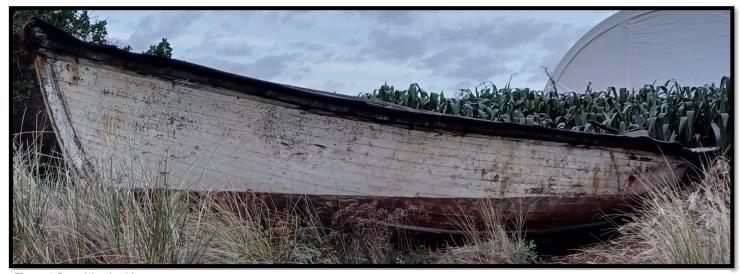
Figure 9 Portside planking.

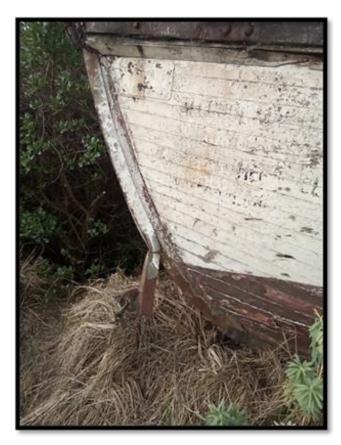
Figure 10 Bent stem capping

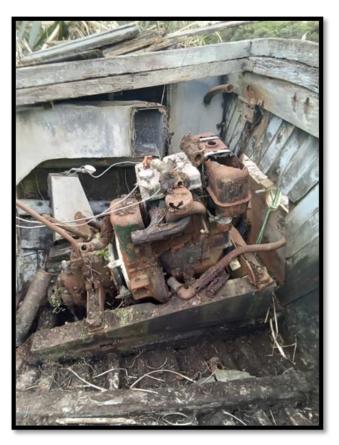
Figure 11 Lister motor in poor condition

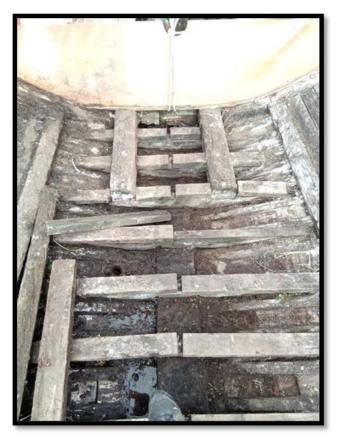
Figure 12 Inside the boat looking towards the stern.

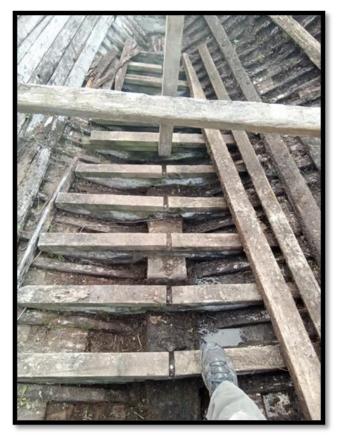
Figure 13 Inside the boat looking towards the bow.

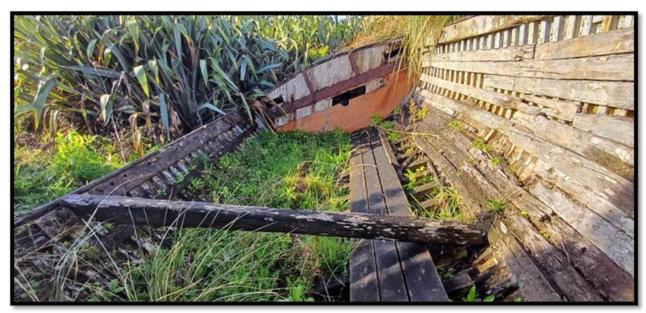
Figure 14 Inside the boat before detritus clearing

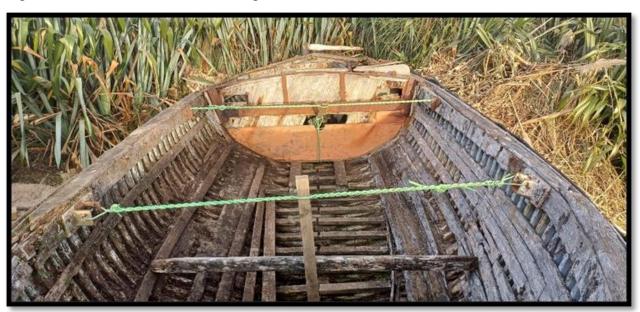
Figure 15 Inside the boat after clearing

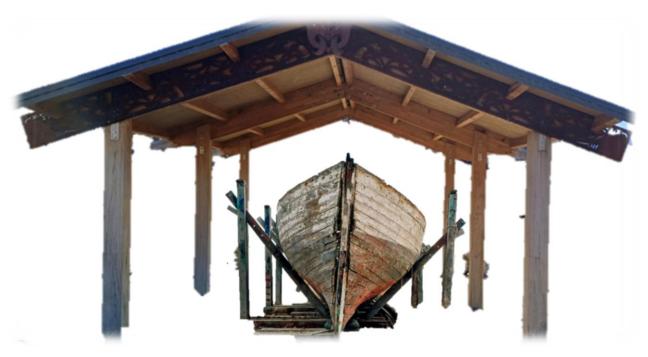
Figure 16 An example of a DOC-built gable shelter with a wooden boat photoshopped

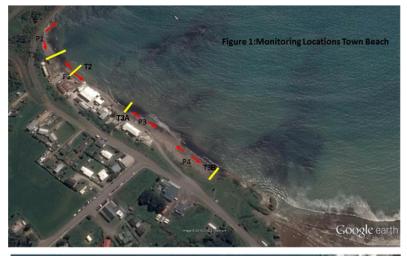
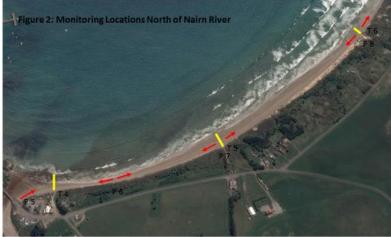
Figure 2.1: Monitoring locations along Town Beach (top) and north of Nairn River (bottom)

Monitoring has been undertaken at the locations shown in Figure 2.1 for the types of monitoring shown in Table 2.2 below.

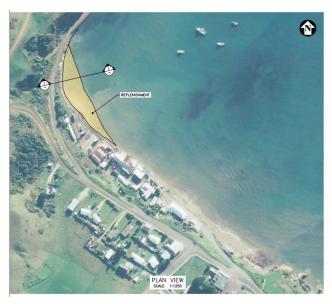
Figure 3.1: Initial beach sand nourishment design extent and profile concept (note sand was also placed further east along Town Beach during construction)

To combat the potential changes in sediment transport in the system and to increase the stability of the perched beach west of the Nairn River (Town Beach), dredged sand material was placed in this area to nourish the beach. It was anticipated before works began that approximately 3000 m³ material be placed along 120 m of the shoreline started from the western end of the bay (refer Figure 3.1). This material was anticipated to be gradually transported eastward along the bay. It is noted that during construction, dredged material was also placed further eastward of this location, extending along the Town Beach in front of the fish factory. Approximately 3300 m³ dredged sand was placed on the Town Beach during construction of the Wharf.

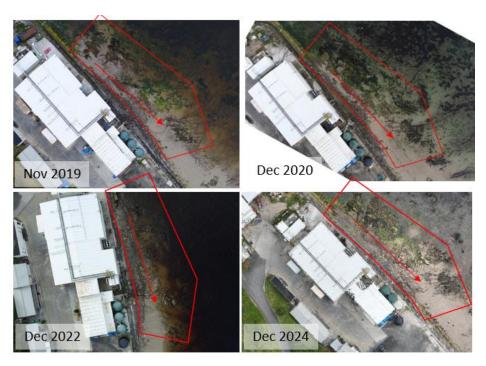
Figure 3.5: UAV photo analysis showing differences in Town Beach sand levels in front of the fish factory between Nov 2019 (top left), Dec 2020 (top right), Dec 2022 (bottom left), and Dec 2024 (bottom right). Arrow shows general easterly movement of sand

Comparing December 2024 and December 2022 aerial photography of Town Beach it reflects the trend of lowering sand level with increased exposure of Tuff rock, gravel and geotextile sandbags (refer Figure 3.5). This has been an ongoing trend that was first identified in the 2019 monitoring round.

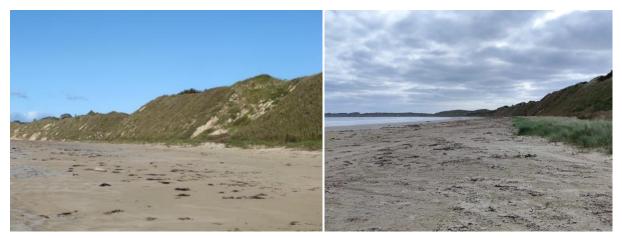
Figure 3.7: Increase in dune vegetation at the dune toe at photo point location P7 between the 2022 monitoring round (left) and the 2024 monitoring round (right)

monitoring round, with the dune toe showing signs of accretion with vegetation establishing both landward and seaward of the dune toe at photo points P7 and P8 (Figure 3.7 and Figure 3.8).

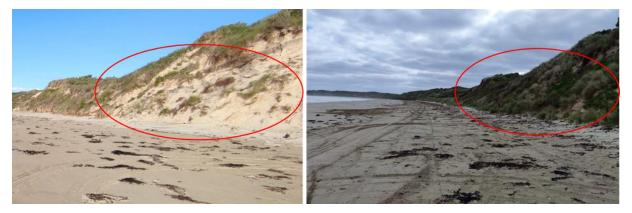
Figure 3.8: Increase in dune vegetation at photo point P8 between the 2022 monitoring round (left) and the 2024 monitoring round (right)

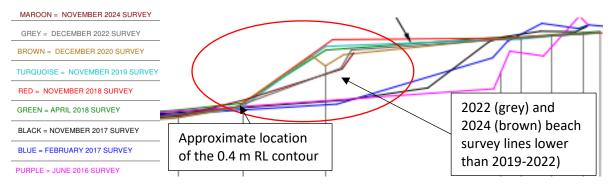
Figure 3.9: Beach levels at the western end of Town Beach (monitoring location T1)

At the toe of the access ramp there is a 40 mm decrease in beach levels when compared to 2022 and at the furthest seaward position there is a maximum lowering of 80 mm recorded 20 m offshore from the toe of the access ramp (refer Figure 3.9).

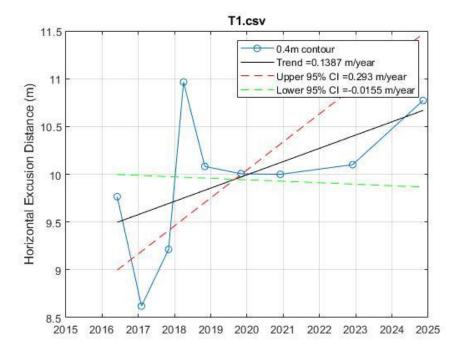
Figure 3.10: Beach profile analysis at monitoring location T1 showing accretionary trend.

Beach profile analysis has been conducted using all survey data for monitoring location T1 (see Figure 3.10 and Appendix C1) to assess trends over time noting that sand placement occurred in 2018.

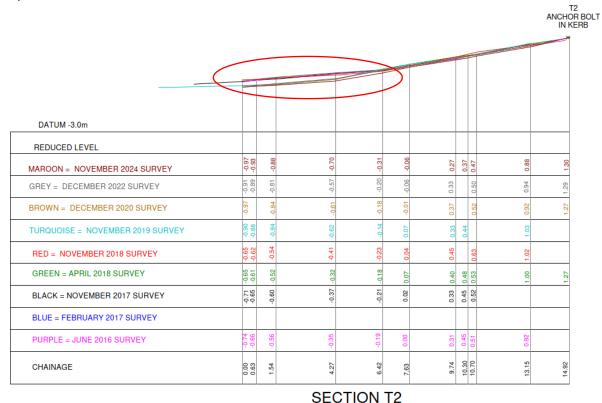
Figure 3.11: Lowering of low tide beach levels seaward of the boat haul out area (monitoring location T2).

Beach levels recorded at profile T2 (Figure 3.11) are up to 10 mm lower than the 2020 and 2022 monitoring rounds and up to 350mm lower than the levels recorded in June 2016. There is a maximum decrease in the 2024 beach levels of 10 mm from the 2022 beach profile. Similarly, to the 2020 and 2022 surveys, there is still a substantial decrease in beach profile below high tide level, when compared to surveys prior to 2019. It is worth noting this monitoring location is seaward of the improved boat haul out area constructed towards the end of the wharf works in 2017.

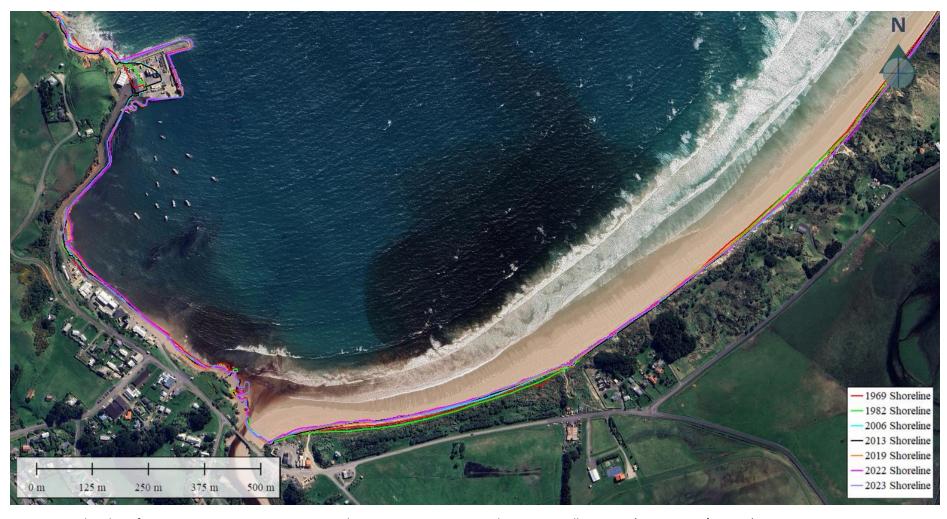
Figure 3.16: Shorelines from 1969, 1989, 1996, 2019, 2022 and 2023 images superimposed on 2022 satellite image (source CNES/Astrium)

Satellite imagery was updated in September 2023. The updated shoreline was analysed for any significant erosion or accretional changes over the last 3 years. There have been no significant changes in the shoreline profile since the 2019 shoreline assessment. Imagery will continue to be monitored and will be updated in future monitoring rounds if and when imagery becomes available.

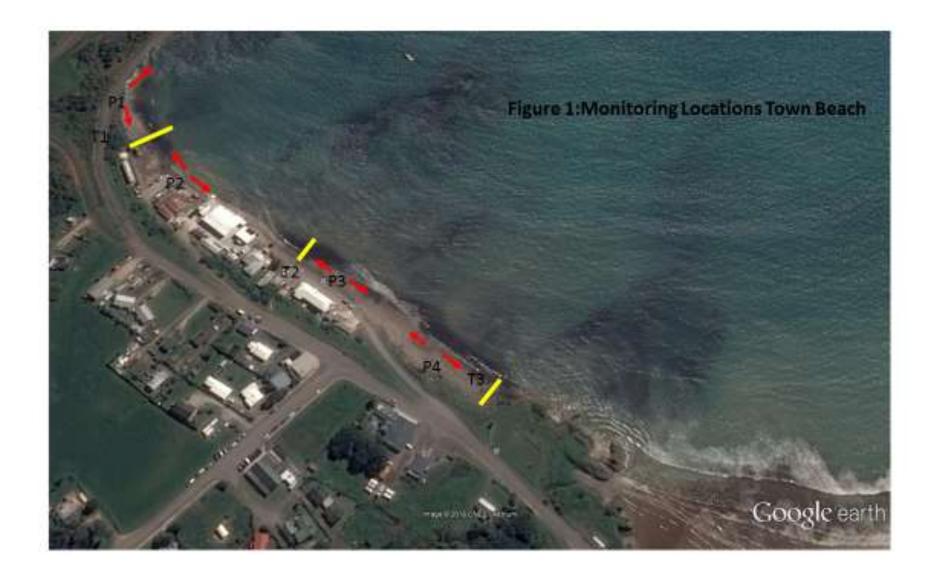
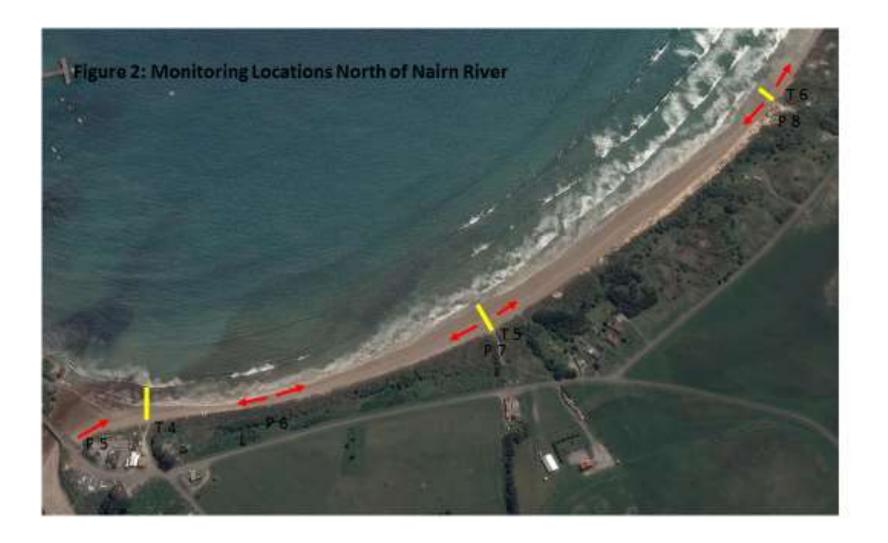
During the construction of the breakwater and wharf, two weekly photographic monitoring and visual observations will be undertaken. The photos and observations will be taken at the high water mark at the locations shown in Table 2. The position of these locations is also shown in Figures 1 and 2. The photos will be taken as close to time of low tide as practical.

Prior to construction commencing a set of baseline beach profiles will be recorded. The transect locations are identified in Table 3. The position of these transects is also shown in Figures 1 and 2.

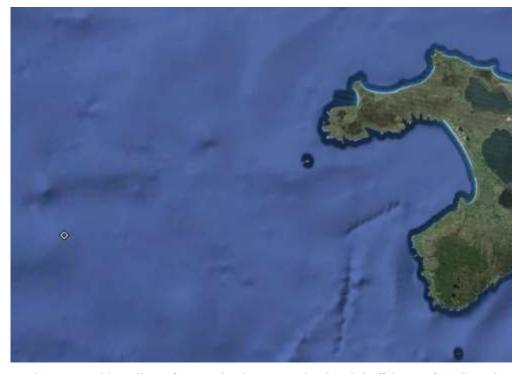
Figure 3 Proposed location of numerical wave output point offshore of Waitangi Bay

Information will be collected on the wave climate reaching Waitangi Bay. This information will be obtained from NOAA Wavewatch III global numerical wave model at an output location 75 km offshore of Waitangi Bay (Figure 3). This output will provide indication of ocean conditions occurring between surveys (i.e. magnitude and frequency of storms).

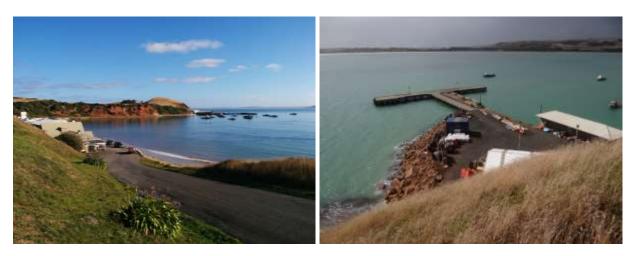
Figure 1-2 Waitangi Bay (left) with the existing wharf (right)

The Waitangi Bay coastline is situated at the southern end of Petre Bay and in the lee of a rocky headland, Tikitiki Hill (Figure 1-1; Figure 1-2). The dominant driver of the coastal processes are swell waves generated by the predominant westerly airstreams south of 40° latitude. These waves are refracted around the Tikitiki Hill headland before arriving in Waitangi Bay from a north westerly direction at a reduced height. The construction of the proposed physical works have potential to modify these wave processes and the resultant sediment transport dynamics within the bay.In regards to site datum's, all levels are reduced to local MSL (2.35 m below LINZ EHN1 survey mark), and all locations are referenced to Chatham Islands Transverse Mercator (CITM)

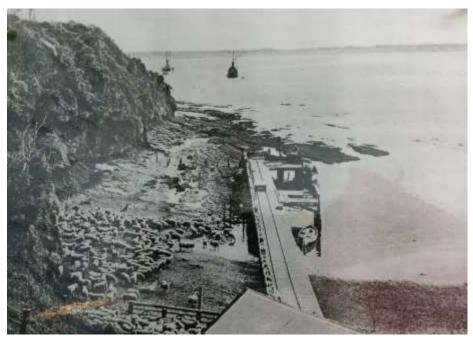
Figure 2-3 Waitangi Wharf 1907 (Source: Waitangi Museum)

The wharf was moved from its original location in the western corner of the bay to the present location at Hanson Point in the early 1930s. Previously surf boats would load cargo at a short jetty and then row out to the trading vessels offshore (Figure 2-3). A 385 ft (117 m) long timber wharf with a 202 ft by 26ft (60 x 8 m) 'Tee' section was constructed (Figure 2-4) to enable larger trading vessels to berth directly (King and Morrison, 1990). Depths off the berth at the time of construction were reportedly 15 to 17 ft (4.6 – 5.2 m). The wharf was upgraded to a reinforced concrete structure in 1979/1980 (Appendix A, Photograph 1) and a small previous reclamation at the base of the wharf was extended to approximately 65 m in length (2,800 m² total area) to allow construction of port facilities. This reclamation is protected on its seaward side by rock rip-rap comprised of both basalt and tuff material (Appendix A, Photograph 2-4). The tuff riprap was placed during the formation of the reclamation. The basalt has been added as replenishment and repair. The basalt rock is relatively resistant to weathering and the tuff material reportedly rapidly deteriorates and is frequently replaced.

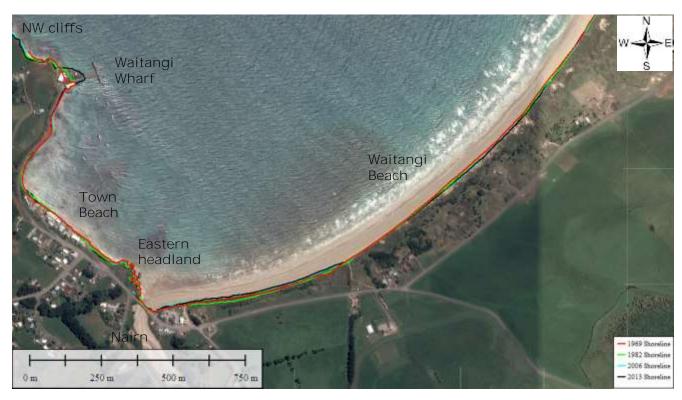
Figure 2-7 Example of historic shoreline positions superimposed on the 2013 Satellite Image

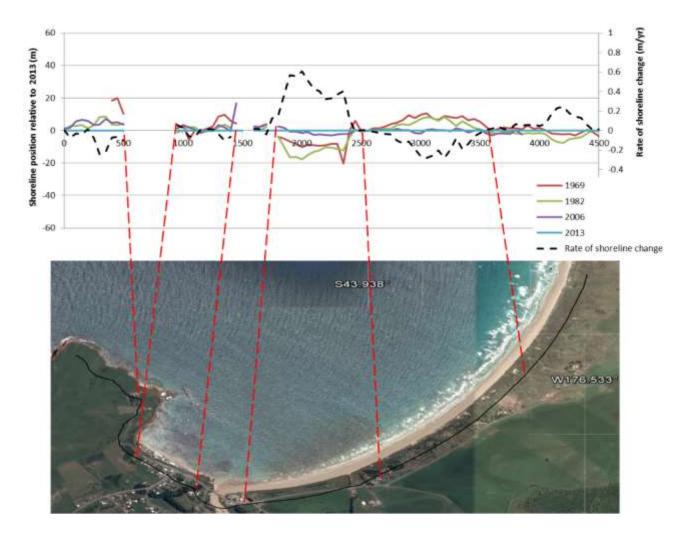
Figure 2-8: Historical shoreline position and rates of change

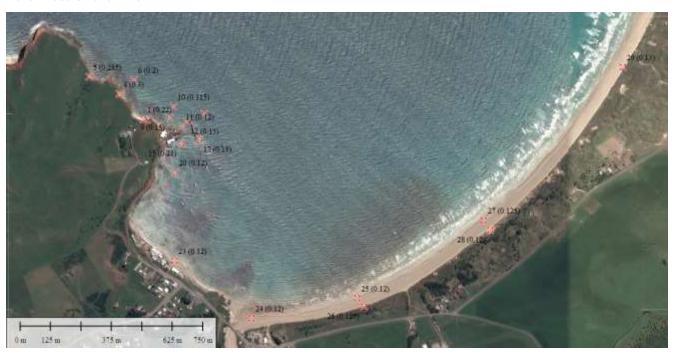
Figure 2-9 Sediment sample numbered locations and median size (D₅₀) in mm.

During investigations, 20 samples were collected from the beaches, nearshore and offshore between 500m northwest of Waitangi Wharf to 1.5 km northeast of Waitangi with their locations shown in Figure 2-9. Tests indicate material to be fine-medium white-grey sands with some shell. Size ranges from $D_{50}=0.15$ to 0.3 mm with a medium grading offshore and adjacent the wharf to $D_{50}=0.125$ mm with a more uniform grading on beach (Figure 2-10). Solid density of the sediment ranges from 2.72-2.79 t/m³.

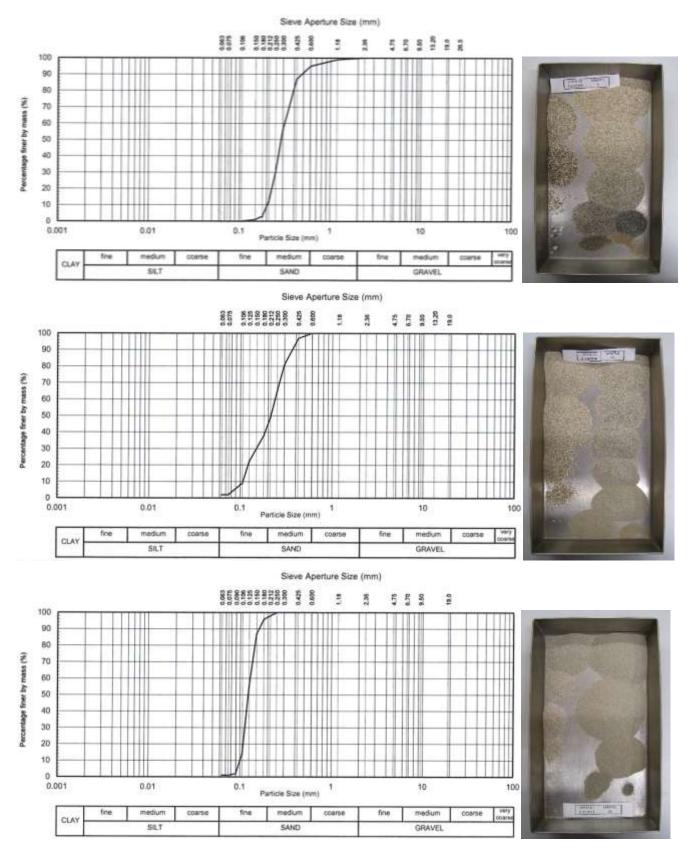
Figure 2-10 Example of sediment gradings from the base of the sea cliffs northwest of the breakwater (top; Sample 5, $D_{50} = 0.28$ mm), at the end of the wharf (centre; Sample 15, $D_{50} = 0.21$ mm) and 500m along Waitangi Beach (bottom; Sample 25, $D_{50} = 0.125$ m)

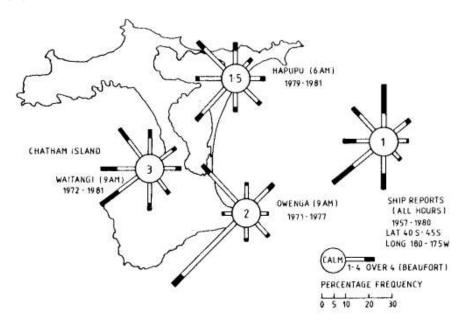
Figure 2-11: Wind frequency record (source: Thompson, 1983)

Observed wind data from Waitangi Bay is scarce with NZ Metservice (Thompson, 1983) compiling daily (9 am) records between 1972 and 1981 (Figure 2-11). Records show wind direction is well distributed, although occurs most frequently from the northwest to southwest. A numerical analysis of a 35 year (1979 – 2013) wind field comprised of hourly data offshore of Port Webb was undertaken by Metocean (2015a). This data has been validated against coastal and open-ocean wind stations around the world with good agreement with 10 minute mean wind speed at 10 m elevation above sea level.

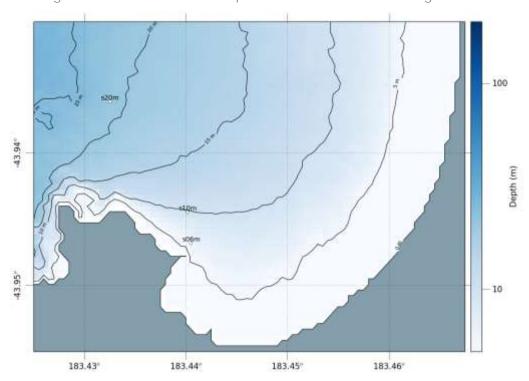
Figure 2-14: Swan model nearshore bathymetry (source: Metocean, 2015a)

Three levels of model downscaling are used to transform the wave fields from a global model domain (11 x 11 km resolution), to a domain including only the Chatham Islands (1 x 1 km resolution) and finally to a model domain including the south part of Petre Bay (50 x 50 m resolution). An example of the model bathymetry and an example wave field are shown in Figure 2-16. Output points are provided in 20 m water depth 800m north of Point Webb, in 10 m water depth 300 m north of the existing wharf and in 6 m water depth 90 m north of the existing wharf.

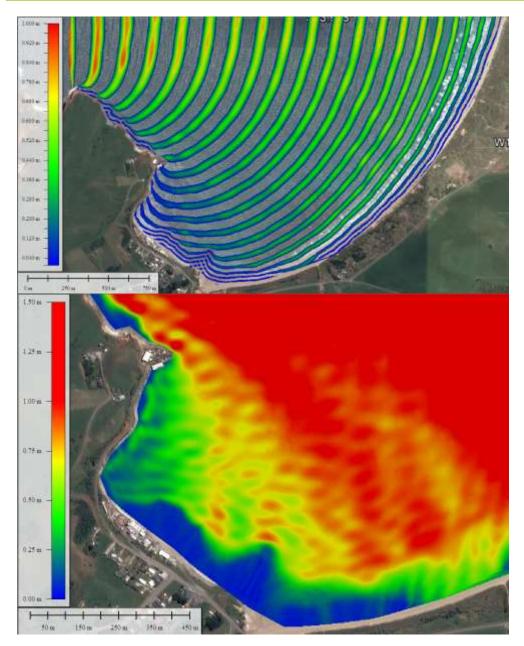
Figure 2-18 Example CGwave wave crest output (top) and wave height (bottom) for a $14\,\mathrm{s}$ wave occurring from 270° at the S20 offshore boundary

Waves have been modelled for a range of incident directions at the boundary between 250 and 280° with periods between 10 and 16 s giving a total of 16 separate monochromatic simulations. Wave height is arbitrary with an adopted height used to find relative height elsewhere within the modelled domain. Initial modelling was undertaken using the existing bathymetry, reclamation and piled wharf structure. An example wave crest and wave height output is shown in Figure 2-18 for 14 s waves occurring from 270° at the S20 offshore boundary (i.e. the average direction). Results show that waves refract in towards Waitangi Bay reaching the wharf from an almost north direction and wave energy moving into this shadow zone through diffraction. While the majority of wave energy reaches the beach north of the Nairn River, energy is focussed onto the reef offshore of the low headland adjacent the Nairn River and on the reef offshore of the hotel. Very little wave energy reaches the shadow zone west of the hotel reef.

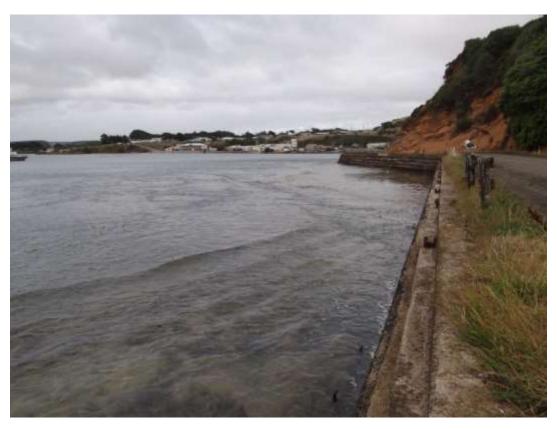
Figure 2-19 Road seawall reflecting oblique incoming waves towards the beach

Reflection off the seawall can be observed during high water levels. This reflection deflects waves that have refracted around the existing reclamation and are approaching from a northeast direction towards the beach from a northwest direction. While this has only been observed in relatively benign conditions, similar reflection reportedly occurs during high energy conditions.

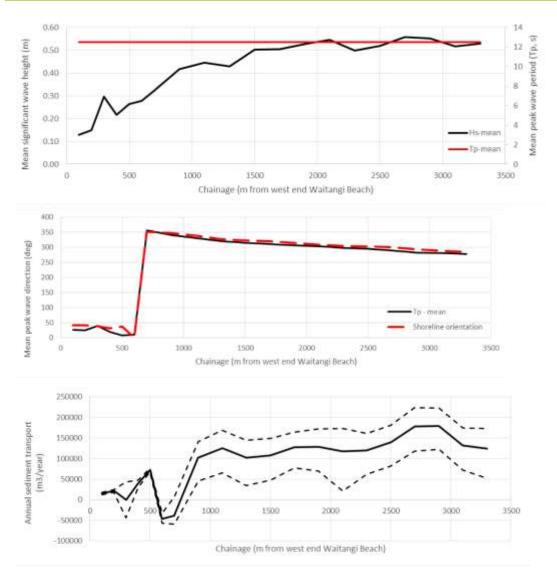
Figure 2-22 Annual mean wave height and period (top), direction and coastline orientation (middle) and potential longshore sediment transport capacity (lower) including the effect of $\pm 5^{\circ}$ wave directional error

Results (Figure 2-22) show the mean significant wave height and peak period for swell, compared to shoreline orientation and the potential longshore sediment transport capacity under these swell conditions. Results show a general south to north transport, driven by the dominant south-west wave direction and increasing as the coastline becomes more exposed. However, the lack of supply from the western end of the bay and observed lack of sediment at the base of cliffs or on the beach indicates that the system contains a dearth of sediment. Therefore, while the potential sediment transport capacity can be calculated, the actual transport is likely to be significantly lower owing to this deficit. A reduction in transport rate is observed between chainage 500 and 700 m in front of the Nairn River Entrance. This reduction is likely due to the effect of the submerged reef fronting the low tuff headland which rotates the incoming waves to near shore parallel. While a large sediment accumulation is not evident at this location, the Nairn River is a sediment sink (refer following section) and accumulation has recently occurred over several hundred metres to the north.

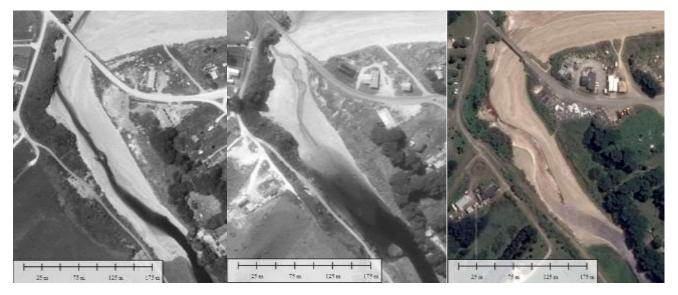
Figure 2-24 Example of sediment accumulated in the lower Nairn River in 1969 (left), 1982 (centre) and 2013 (right)

The bridge over the lower Nairn River was initially constructed in 1947 and has reduced the width at the entrance from an estimated 70 m initially to 35 m today. Early imagery of the lower Nairn River (Figure 2-23) showed similar coastal sediment accumulation indicating that this has been a long-term process. Sediment accumulates over a 15,000 m³ area up to 300 m up-steam of the Waitangi Rd Bridge with historical imagery in Figure 2-24 showing the extents and volume of sediment vary over time. While geotechnical investigation and long-term monitoring is required to make accurate estimates of sedimentation volumes and rates, it is likely that the lower river contains between 5,000 and 30,000 m³ of marine sediment at any time.

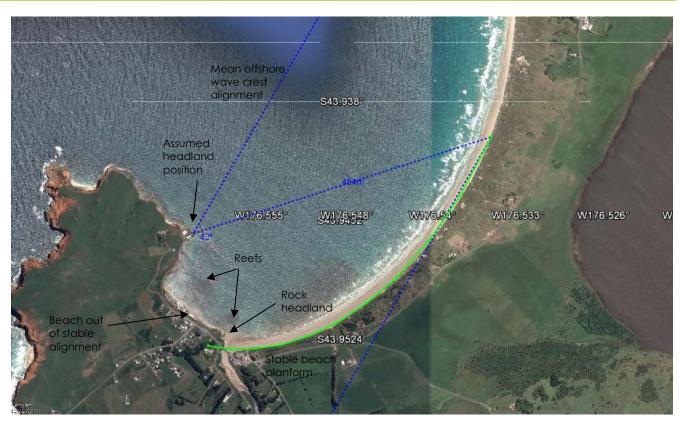
Figure 2-25 Analysis of an equilibrium planform for southern Waitangi Bay

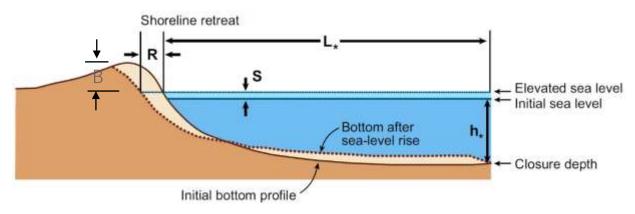
Figure 2-26 Bruun model of shoreline response to sea level rise

For a given historic sea level rise of 85 mm over the past 50 years, the Bruun model predicts shoreline recession of 4 m at the Waitangi Town Beach, increasing to 7 m to the north along Waitangi Beach. Given the coastline here is close to a stable equilibrium angle (Figure 2-25), historic sea level rise could explain the background erosion observed here.

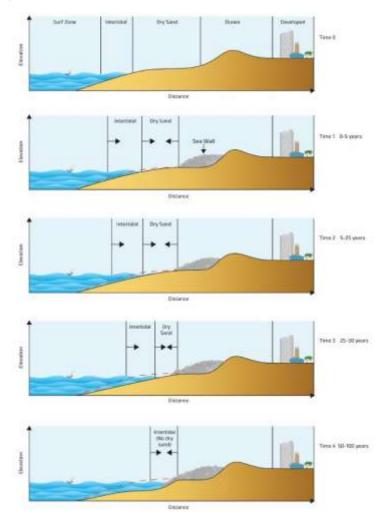
Figure 2-27 Example of the long-term shoreline response to a seawall on an eroding beach

Seawalls are constructed where the natural landward migration of the shoreline impacts on human assets. The seawall is intended to protect the land behind the structure only. They do not protect the fronting beach and, if the coast is in a state of long-term recession, the beach will gradually be lost in front of a wall (i.e. as shown in Figure 2-27). Similarly, seawalls will not protect adjacent land from ongoing erosion and the erosion will continue adjacent to any constructed wall, potentially at an increased rate due to turbulence, reflected waves and the deficit caused by sediment trapped behind the wall.

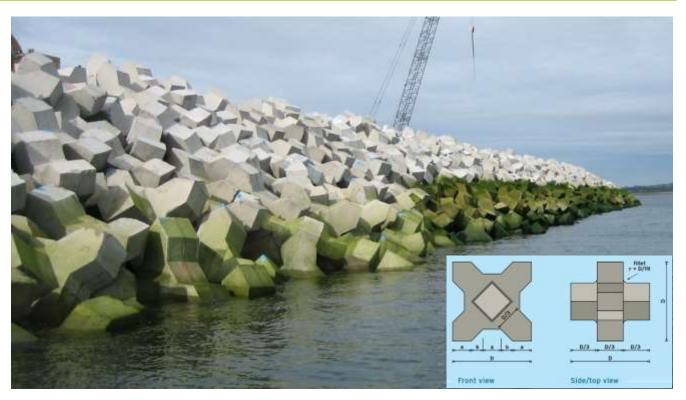
Figure 3-2 Example of breakwater constructed using Xbloc armour units (source: DMC, 2013)

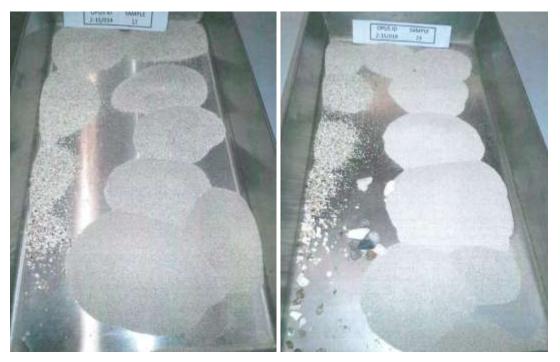
Figure 3-3 Comparison of proposed replenishment sediment (left) with existing beach material (right)

It is proposed to replenish the beach at Waitangi with sediment dredged from around the wharf structure as part of construction of the reclamation and breakwater. This dredged sediment has a similar mean diameter ($D_{50} = 0.125$ mm) to the existing beach sand (Figure 3-3) meaning that the beach profile grades are likely to be similar. The grading of the existing beach sand is more uniform than the dredged replenishment material indicating that the replenishment material is better sorted and that some of the placement material is likely to be more mobile and lost from the beach system. An overfill ratio of 1.7 has been initially assessed meaning that approximately 60% of the material placed on the beach will be retained with the remainder migrating alongshore or offshore over time.

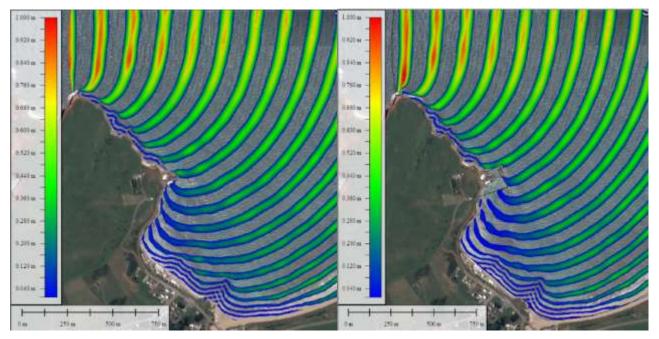
Figure 4-1 Change in wave crest patterns construction of the enlarged reclamation area and breakwater

While these changes are very small and may not result in noticeable effects, the change in wave climate may modify longshore and cross shore sediment transport processes as the reduced wave climate transports less sand to the east and causes less movement across the surf zone. These are discussed below.

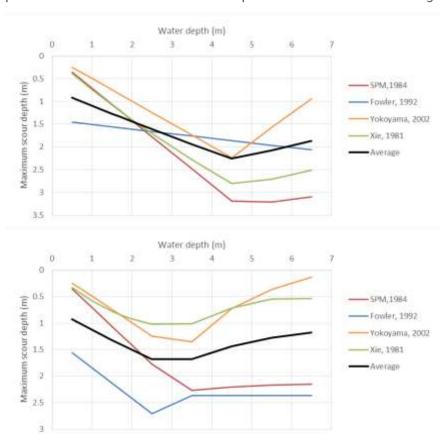
Figure 4-4 Maximum theoretical scour depth for the 100 year ARI swell (top) and wind-wave (bottom) conditions

These scour depths may reach the underlying rock depending on sand depths at the time and have been allowed for in design with larger volumes of rock used along the breakwater toe. This 'toe protection' rock is sized to limit the potential for toe scour damage to the structure.

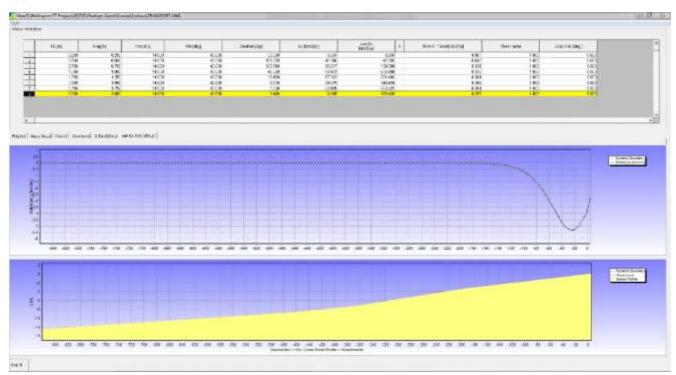
Figure 4-5 Example of longshore sediment transport (cross-shore rate shown in centre panel) northwest of the proposed breakwater calculated using the numerical model Unibest CL+.

Under wave conditions, sediment is transported along the sea bed and in suspension. Sediment transport along the seabed is highest within the inner surf zone where wave velocities at the seabed are highest and reduces with distance offshore. The longshore transport model Unibest CL+ (Version 7.1, Deltares 2011) was used to compute the annual sediment transport *potential* at the proposed breakwater location. The model (example in Figure 4-5) shows that sediment transport is highest in 0 - 2 m water depth, decreasing to zero transport offshore of 4 m. This model computes the sediment transport *potential* with actual transport dependent on the availability of sediment in the system. Given the rocky nature of the nearshore to the northwest of the breakwater, actual transport is likely to be significantly lower. The key finding, however, is that the potential for longshore transport seaward of the 4m depth contour is effectively zero indicating that sediment is unlikely to be transported around the end of the breakwater that could accumulate in the breakwater lee.

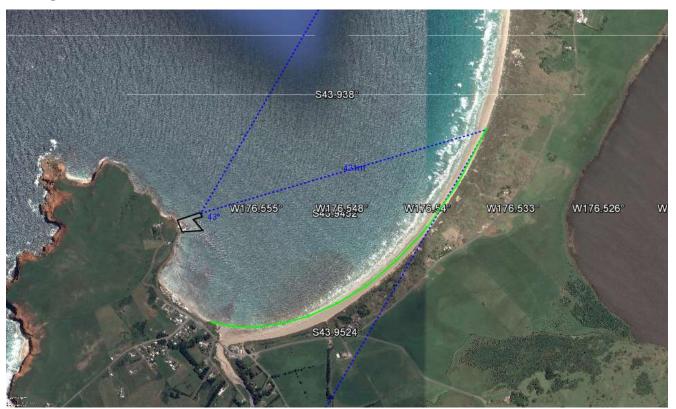
Figure 4-9 $\,$ Analysis of an equilibrium planform for southern Waitangi Bay with reclamation and 60 m breakwater

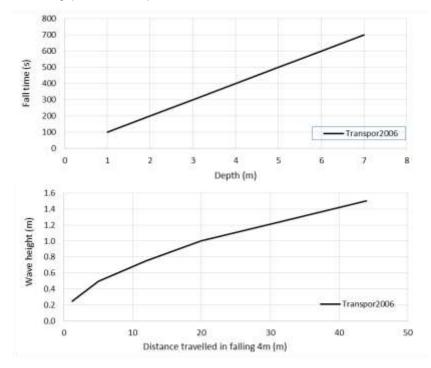
Figure 4-10 Sediment fall duration (s) for range of depths and distance travelled while falling 4m for a range of wave heights

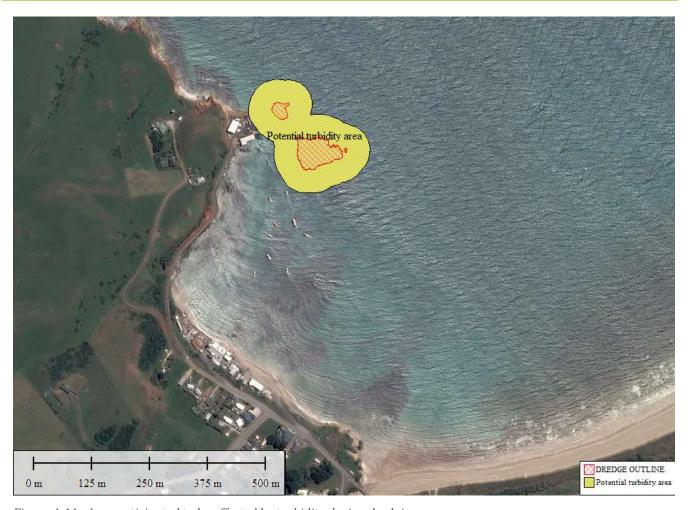
Figure 4-11 Area anticipated to be affected by turbidity during dredging

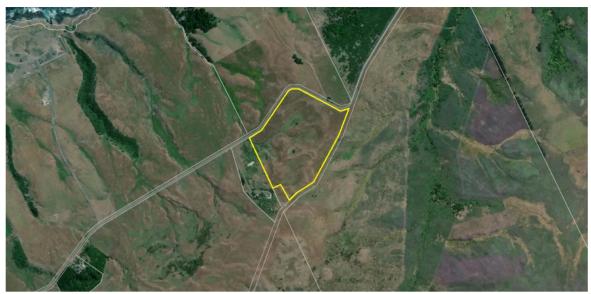
Figure 1 - Site location

The application site is located approximately 5km southwest of Waitangi and is legally described as Part Otonga 1C2 Block and is shown in Figure 1. The proposed site occupies 13ha of undulating hill country generally in pasture.

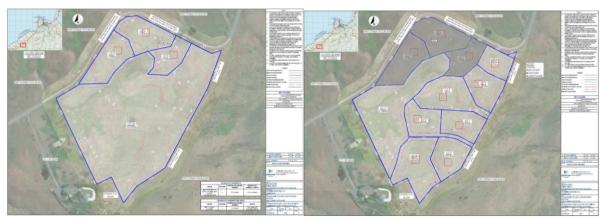
Figure 2 - Stage 1 of the proposed subdivision

Figure 3 – Stage 2 of the proposed subdivision

The plans for the two-staged subdivision are shown in Figure 2 and Figure 3 below and a summary of the allotments is in Table 1.

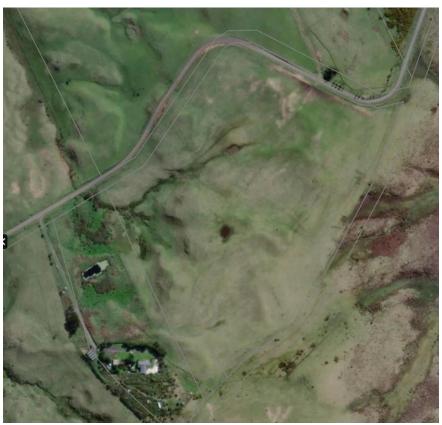
The aerial image of the site below shows a likely overland flow path near / from the existing "dams" on the site. Both dams are in area to be subdivided as part of Stage 2 – one is on a proposed lifestyle lot (Lot 8) and other is on lot to remain undeveloped/planted (Lot 11). The majority of overland flow path appears to be in Lot 11 but there's also a portion within Lot 8 and 10 (which will need to be considered when siting building platform and on-site wastewater disposal systems). Please provide any relevant comment on this matter.
